Inspection/meeting notes and pictures of Weyerhaeuser – Longview BART emission units.

Meeting occurred on Feb. 13, 2008 to go over comments on the BART report. The company will respond to the comments and follow-up a short time later with a revised BART report. Main plant contact was Greg Bean and the consultant was Jay Willenberg of CH2M-Hill. Marc Crooks requested to accompany me to this meeting/inspection. This was my first visit to this plant site.

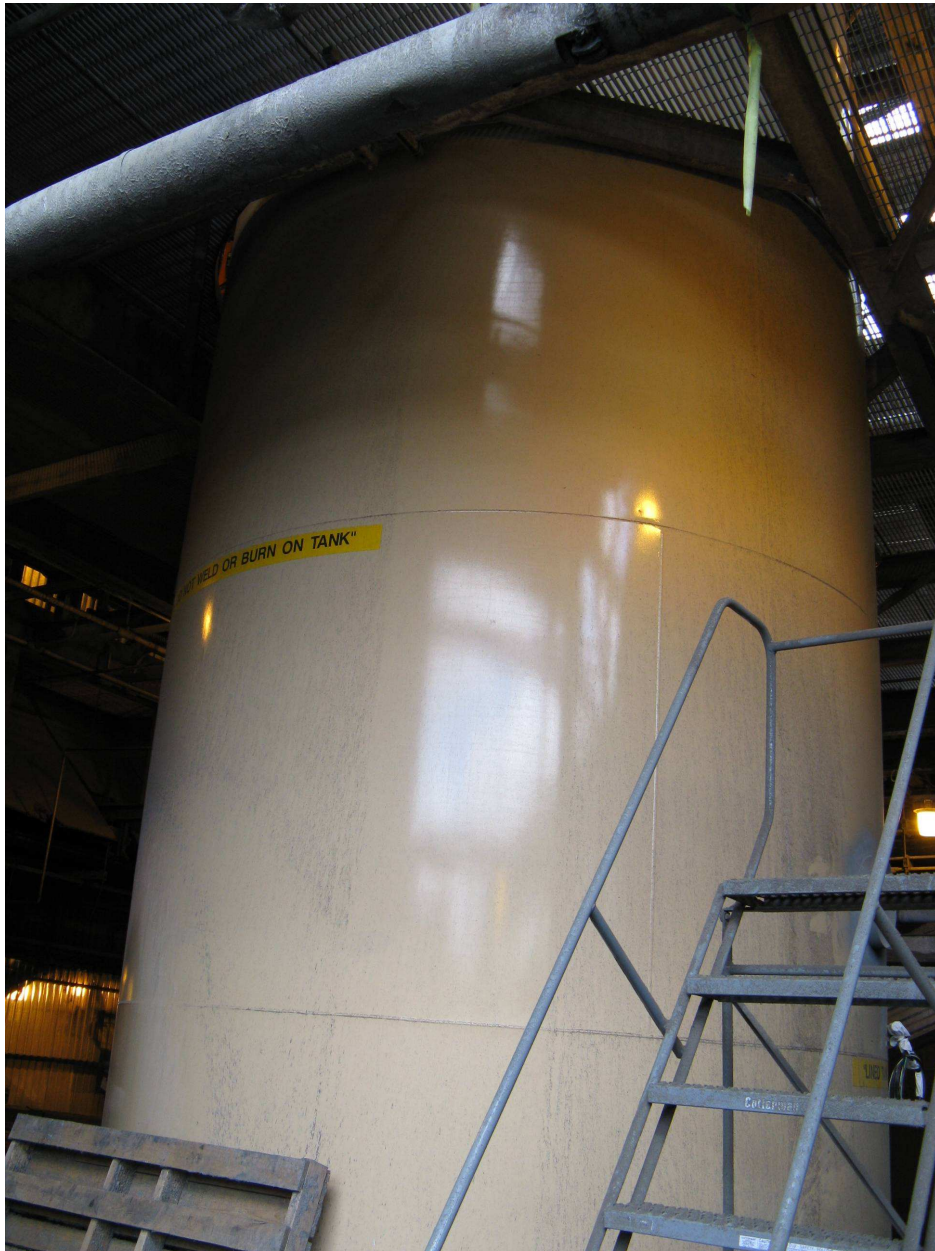
This is a picture of the Trona storage tank from the west. Tank was said to contain storage of the Trona, and milling equipment to grind it small enough to be injected to the boiler exhaust. The injector is via a pipe about 2 in. in OD blowing the Trona into the stack. Staff couldn't confirm if just a pipe or it had multiple injection points.

Boiler is to the left and ESP and stack are to the right.

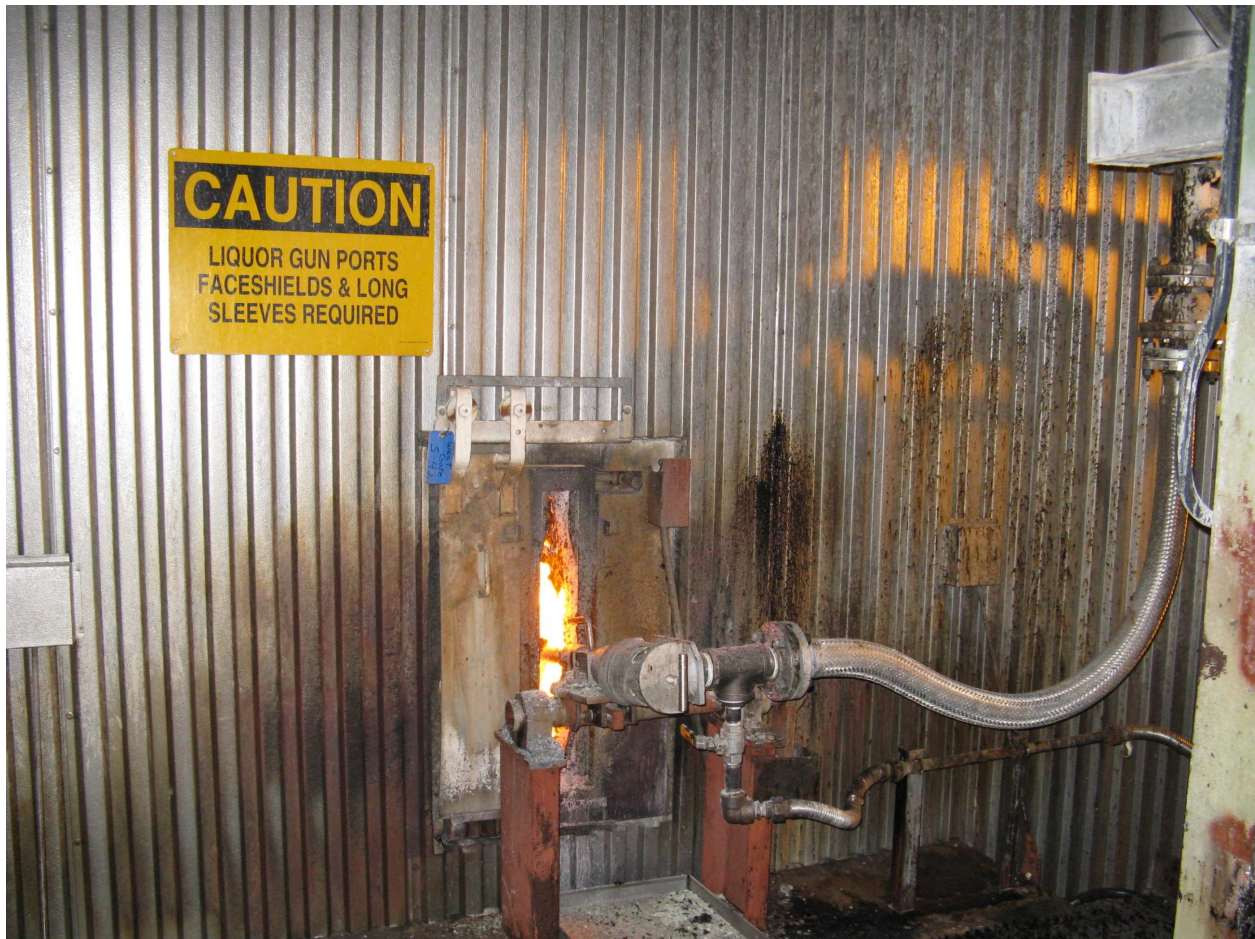
This is a picture of one of the black liquor injectors. The pipe OD is about 1.5 inches. The firebox is visible in the slot. The injectors are below the tertiary air ports and above the secondary ports.

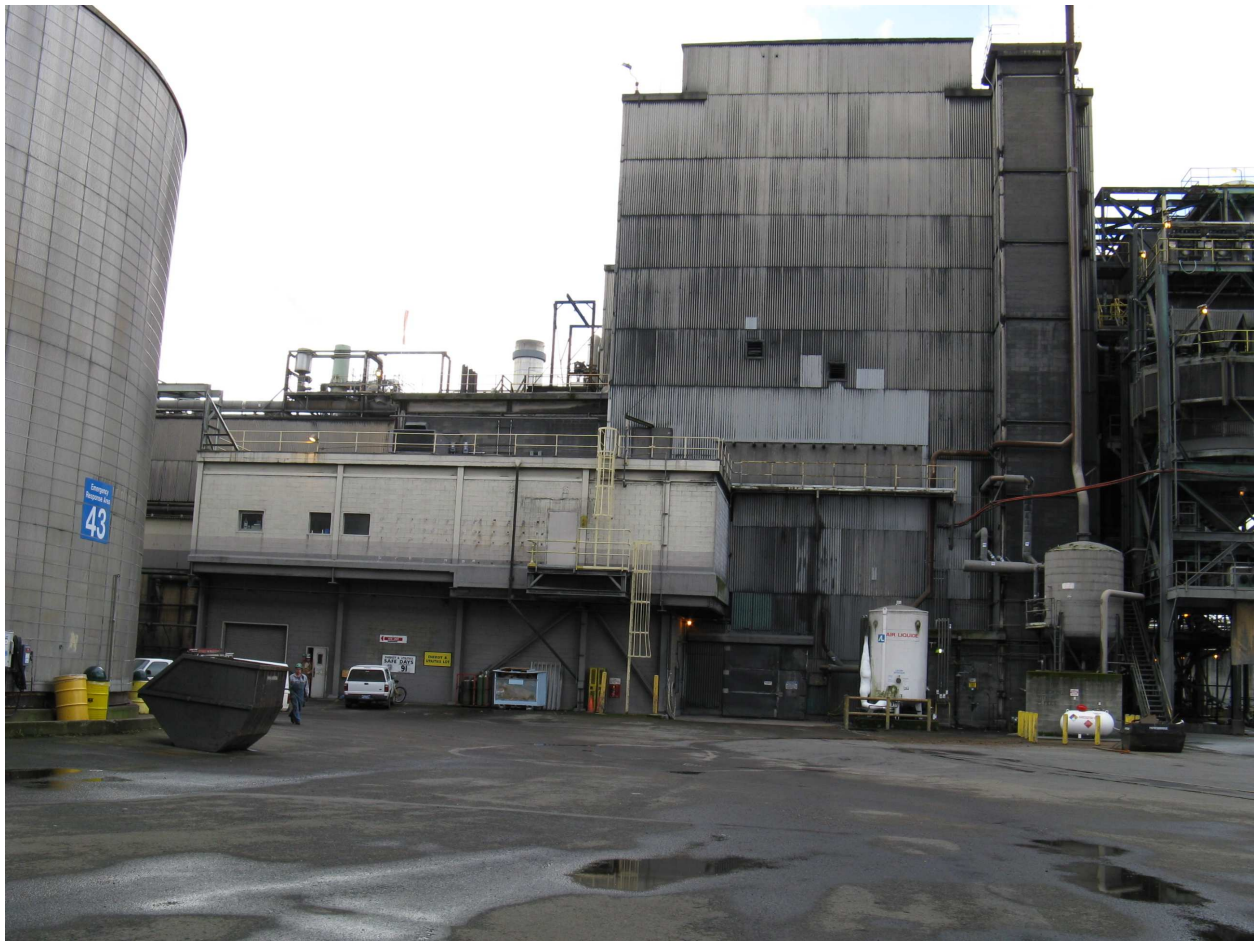
PB#10 building. The old gravel filter is visible on the right side of the picture. The power boiler is in the tall building at center. The large tank on the left is for black liquor storage.

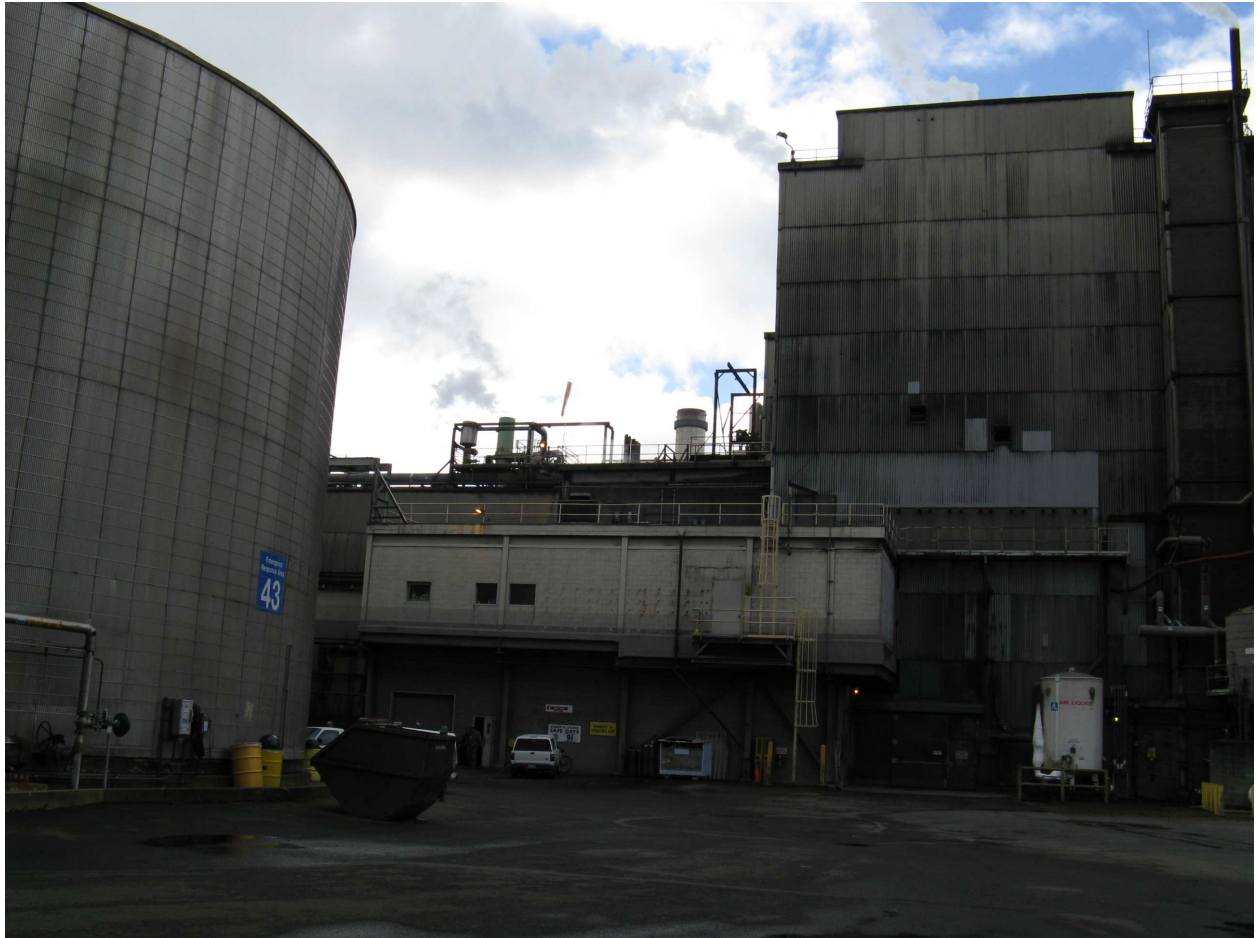
New Power boiler stack behind boiler building. Stack does not exhibit any opacity. Need to look for heat waves to see it is operating.

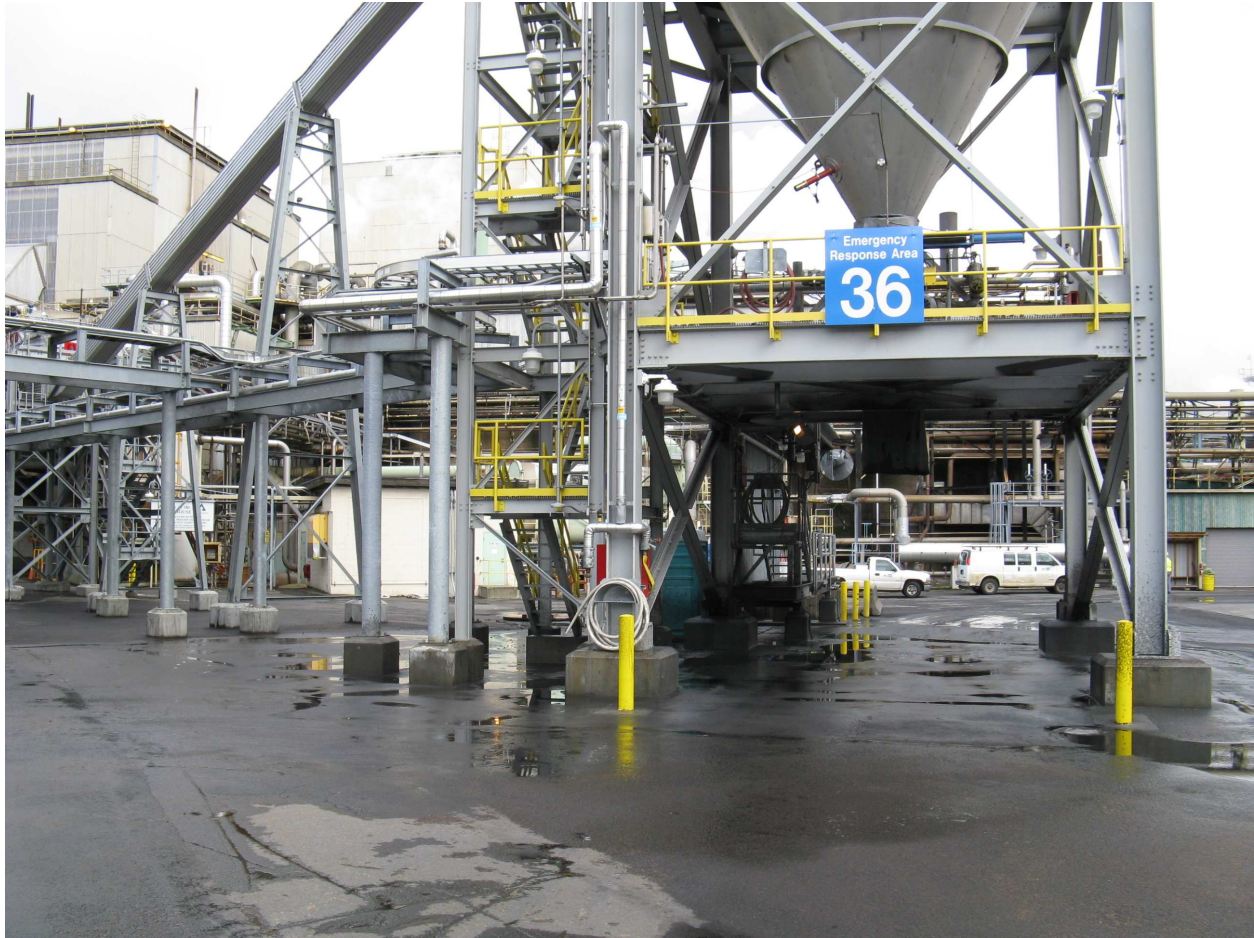
This is the fly ash silo/load out location. The fly ash is transported off site by tractor trailer. There is minimal space to maneuver the truck and trailer into the bay.

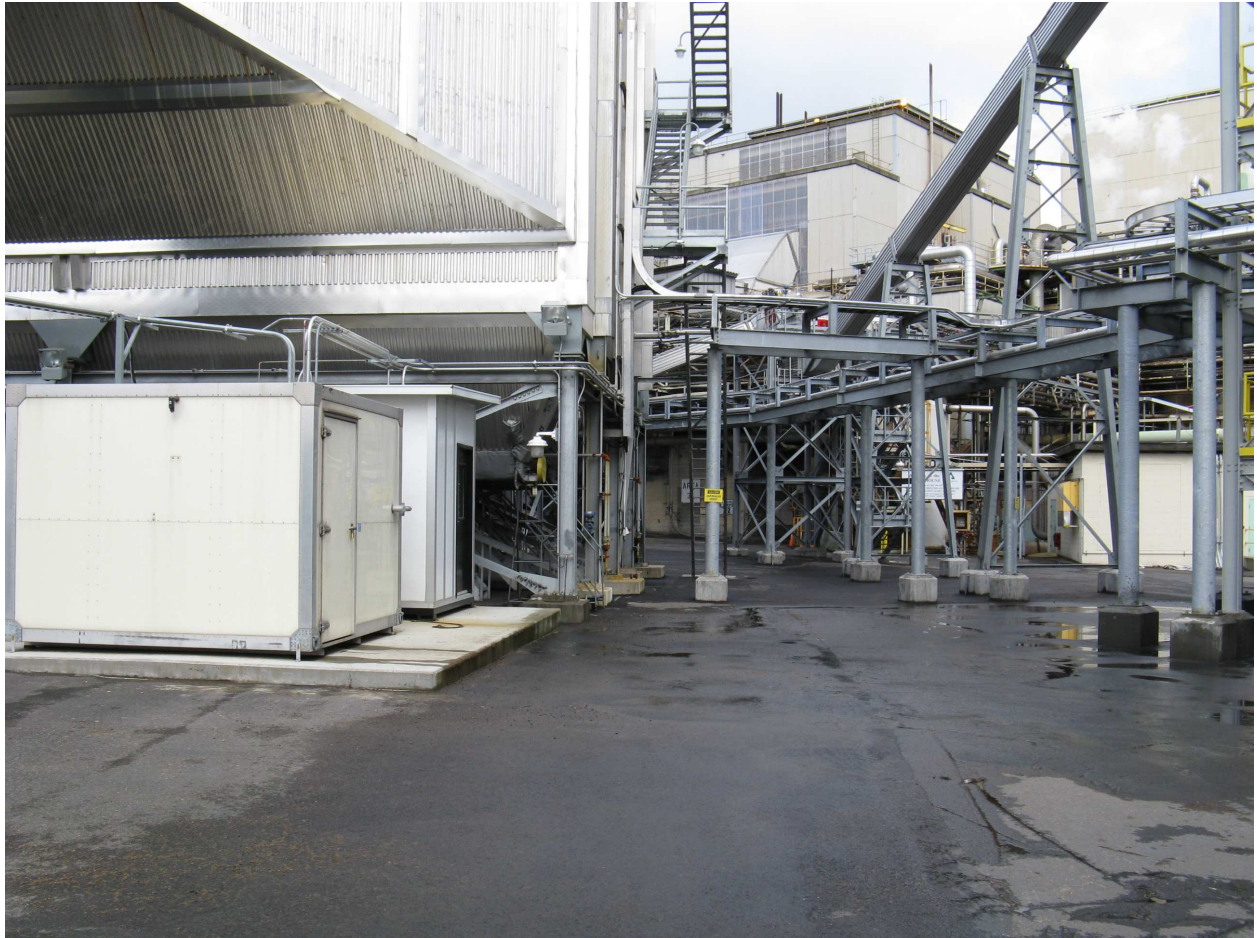
Back end of powerhouse building. Economizer is inside the lower building section in back. The big silver box on left is the new ESP and the shelters contain the emissions monitoring equipment.

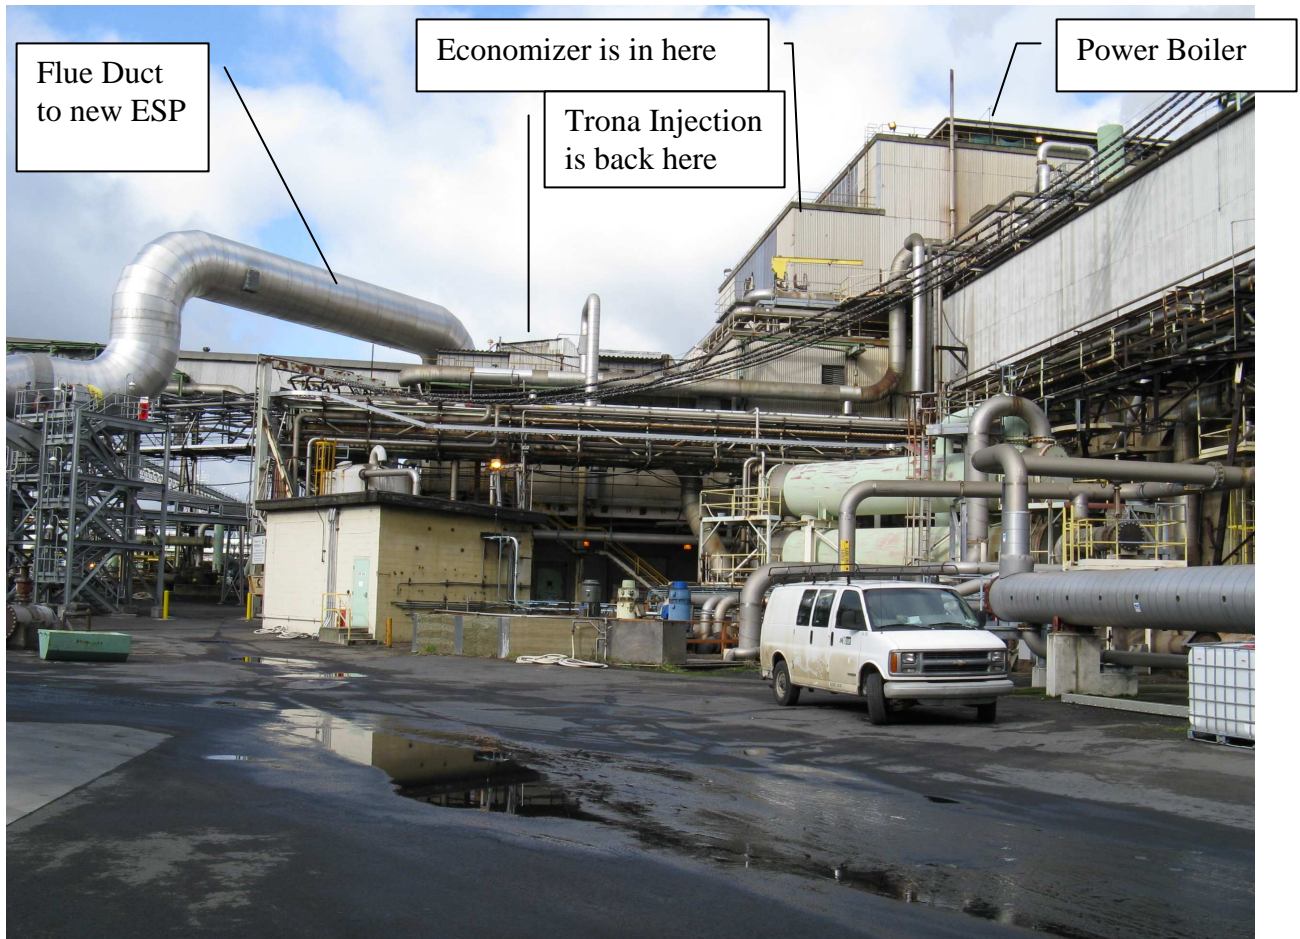
Overview of back end of Power Boiler #10

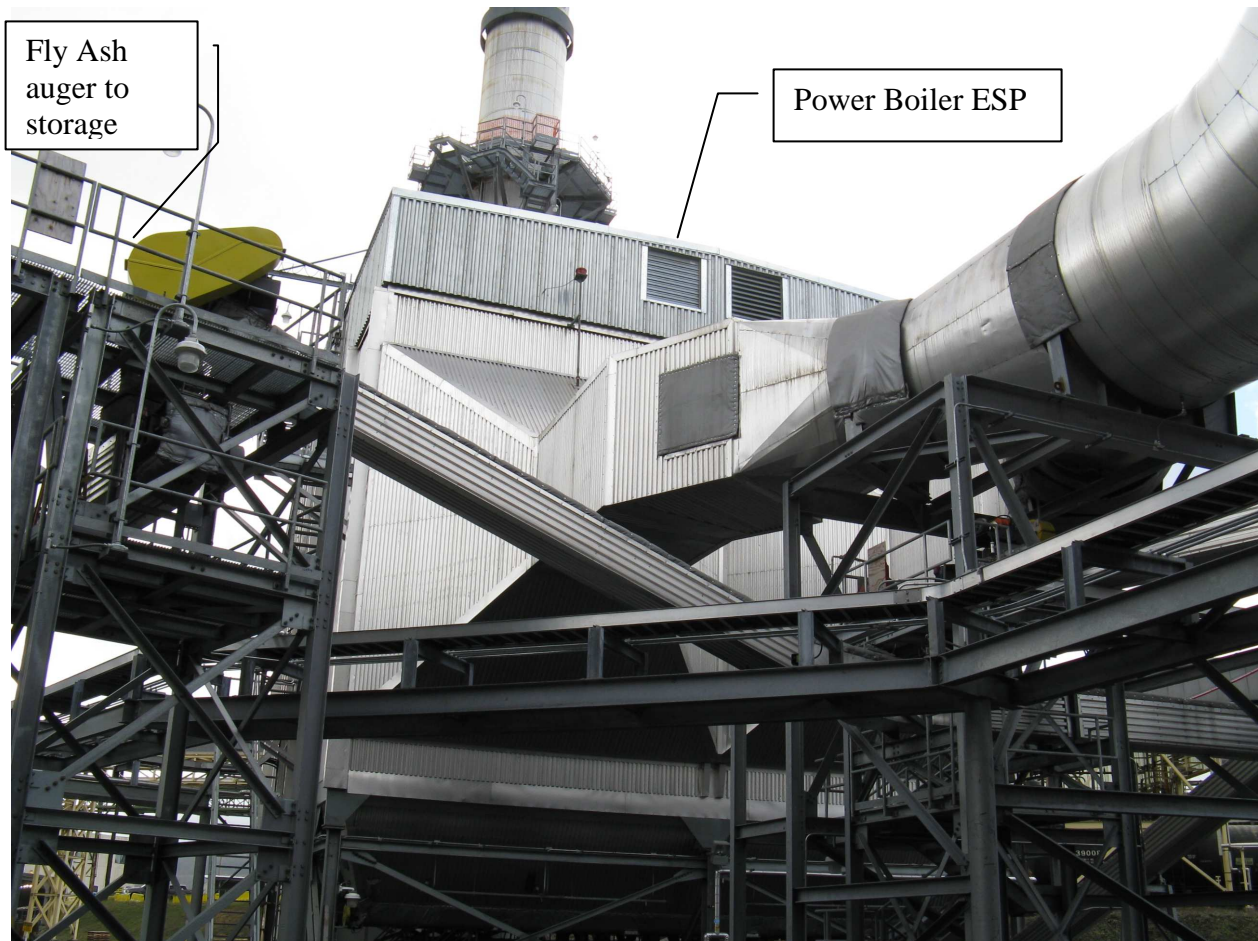
The ESP and new stack along with duct from the boiler building.

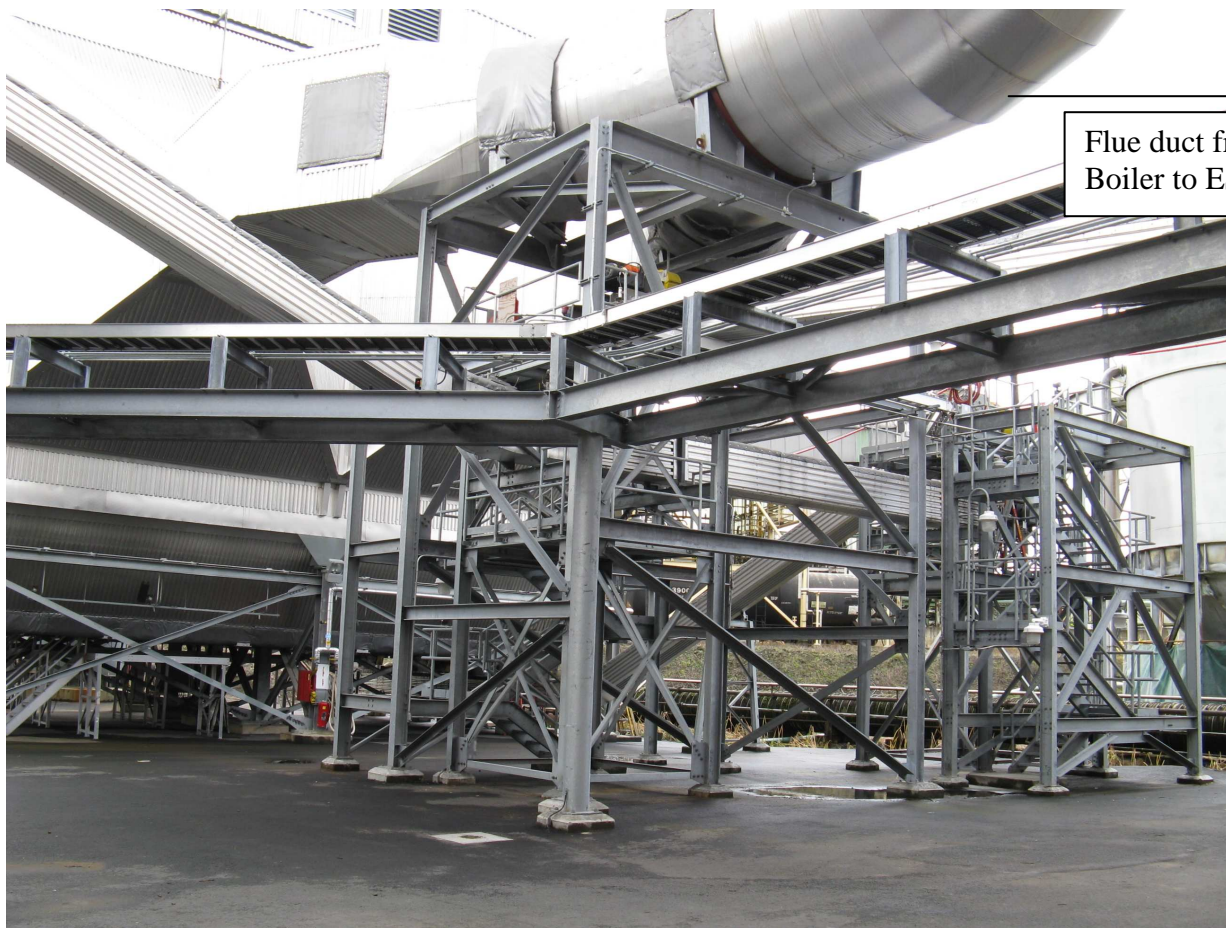
Flue duct from Power
Boiler to ESP

Ground level view of the ESP showing structural supports necessary to support the ductwork and fly ash conveyer.

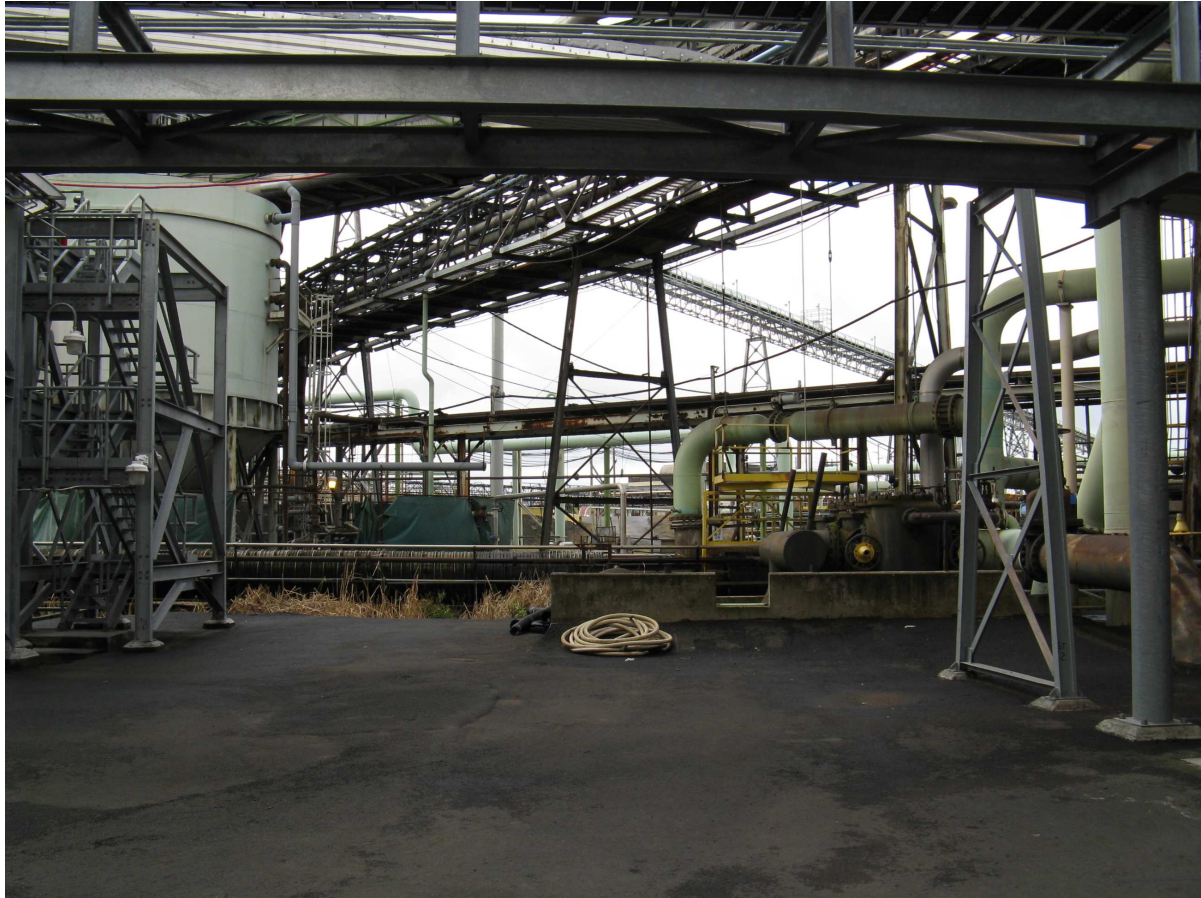
The clear area in this picture was necessary to bridge major plant water and wastewater lines that run underground here.

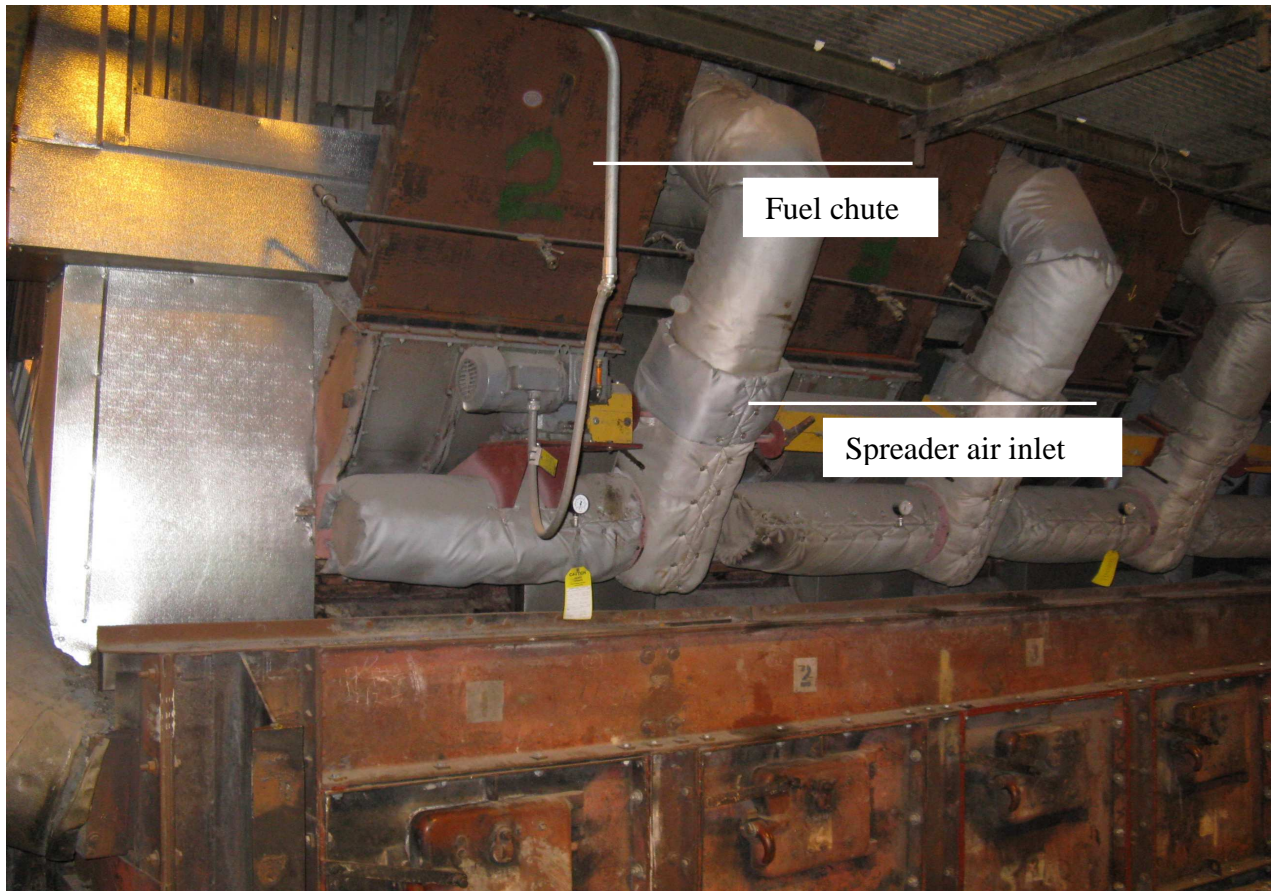
Fuel inlet to pneumatic spreaders for power boiler. The air to drive the spreader is carried in the silver pipes. The fuel comes down the steel chutes. The fuel is caught up in the air flow and hits a steel plate in the firebox and is then spread across the fire grate. The air for the spreading system is part of the combustion air but is controlled separately from the main forced draft blower

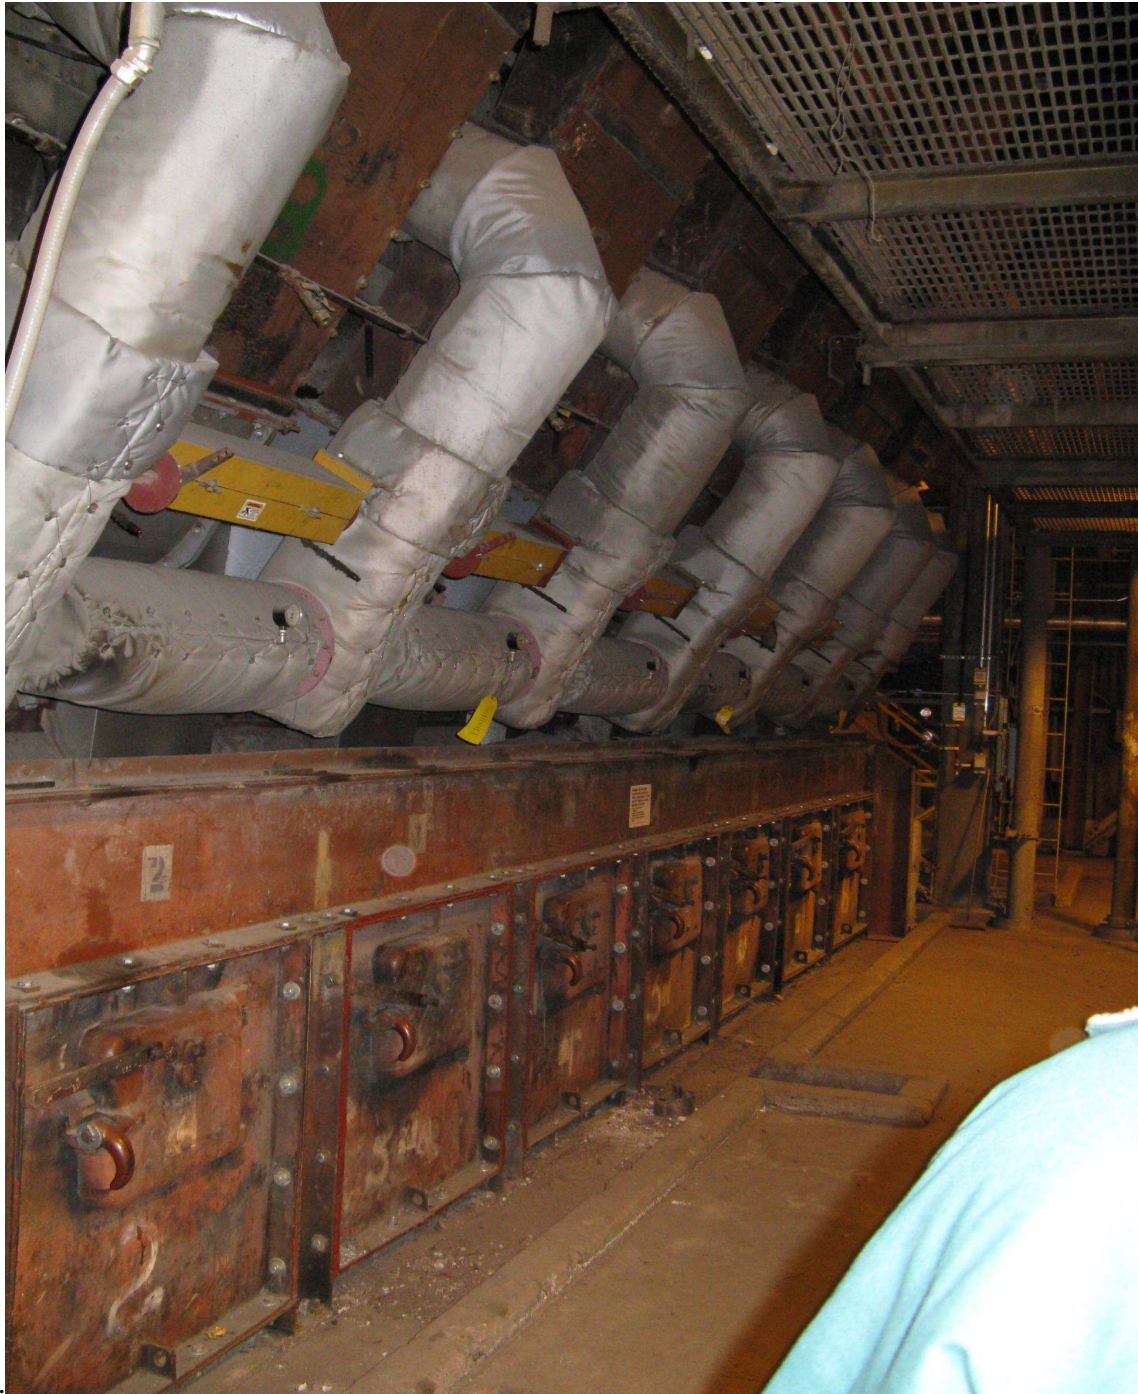
Another picture of the fuel inlet system showing the entire wall of the boiler.

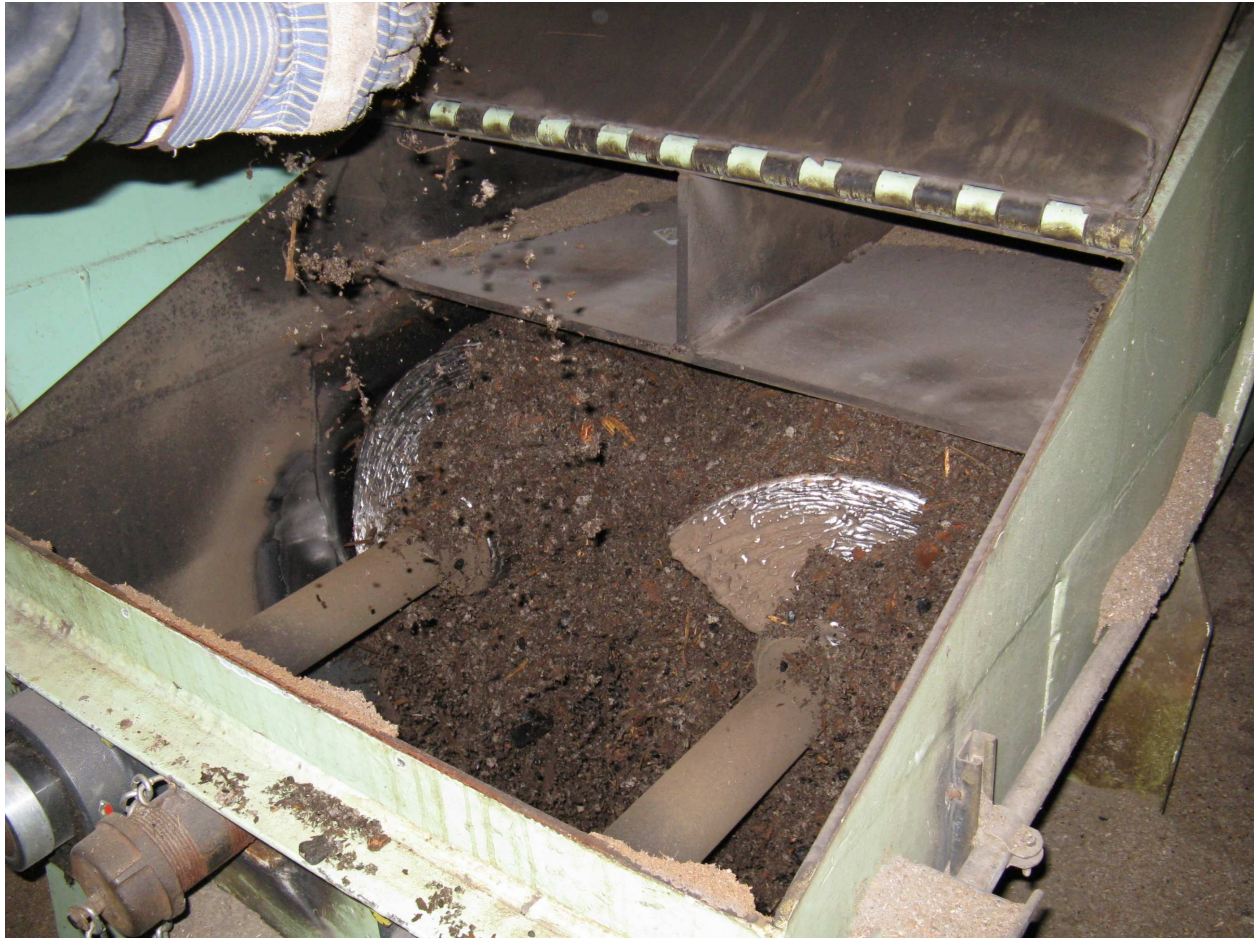
Fuel auger. The primary fuel on this day was wood with sludge and a minimum of coal.

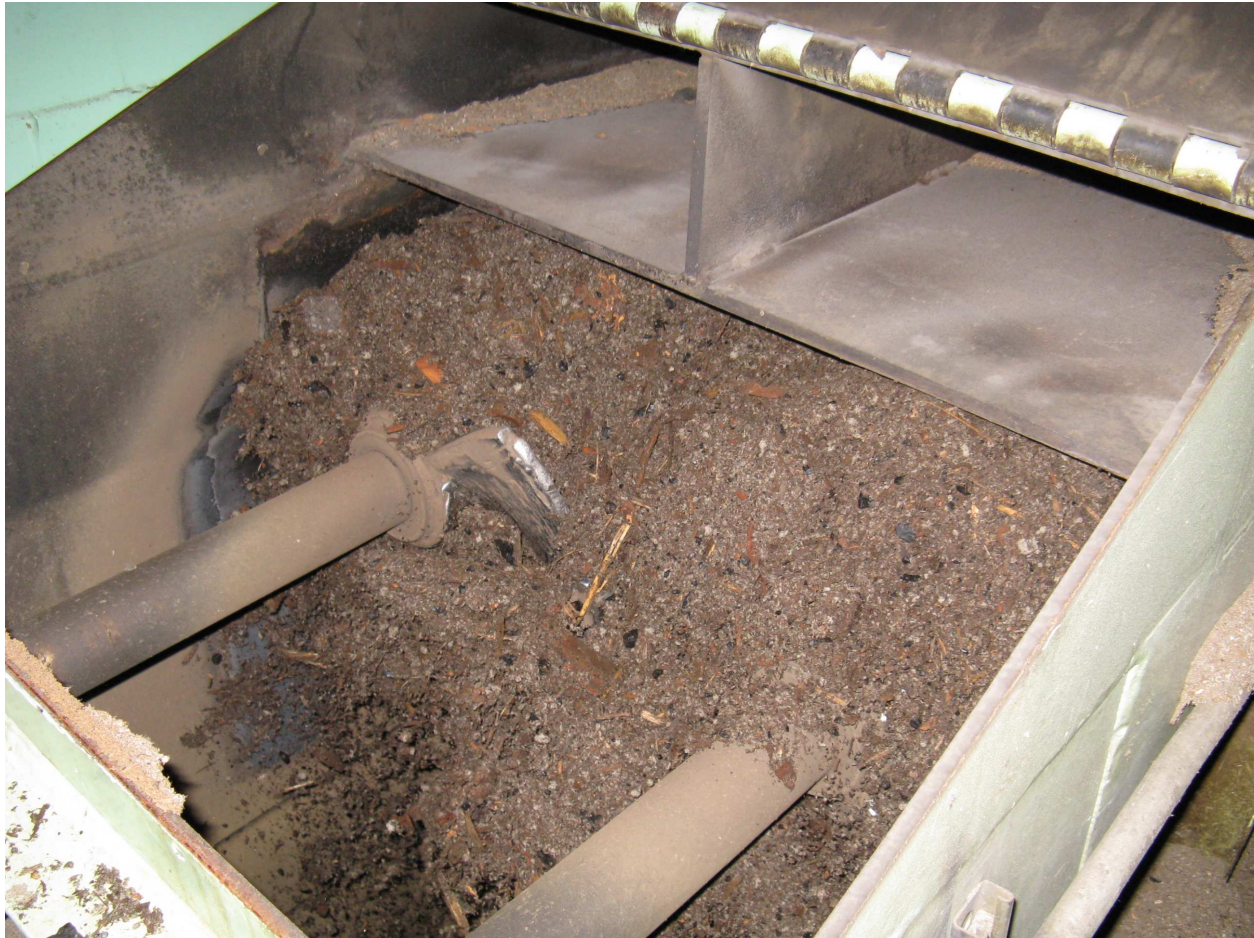
The brown sticks are wood, black pebbles are coal, the rest is wood fiber and sludge. The coal is 'lump' coal and may range in size from 1/8" to 2" in size. Coal is purchased on the open market . the plant does not use enough to justify a unit train or, they believe, to negotiate a long-term supply contract with a supplier. The plant is not equipped to store or unload a unit train of coal.

On an annual average, about half of the 1,000 MMBtu/hr heat input is comprised of coal, though on any given day, the fuel used may be primarily wood, coal or oil.

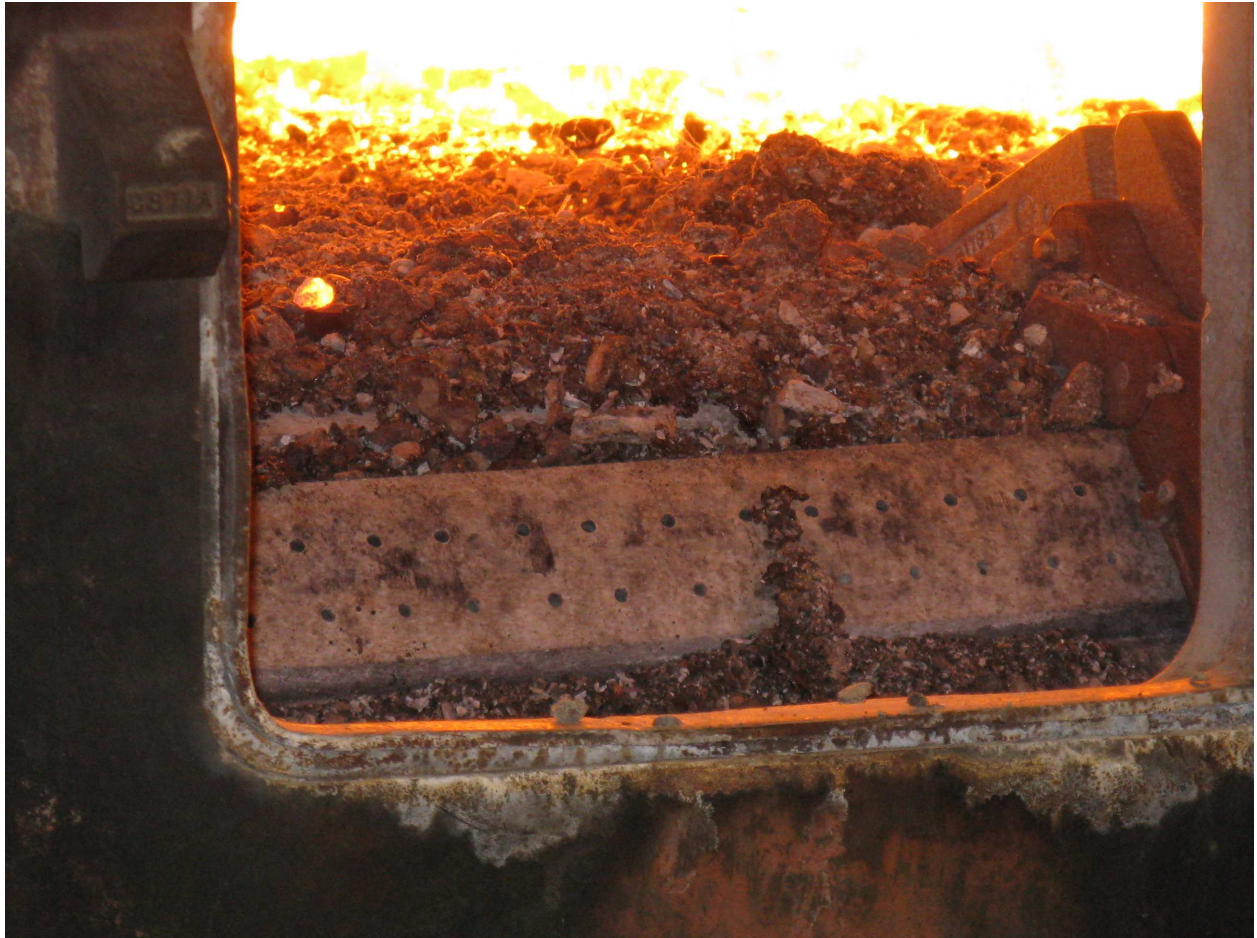
Boiler firebox showing the steel bars of the moving grate system. About 40% of the combustion air comes through the grate and is necessary to keep the grates clean and burn the char.

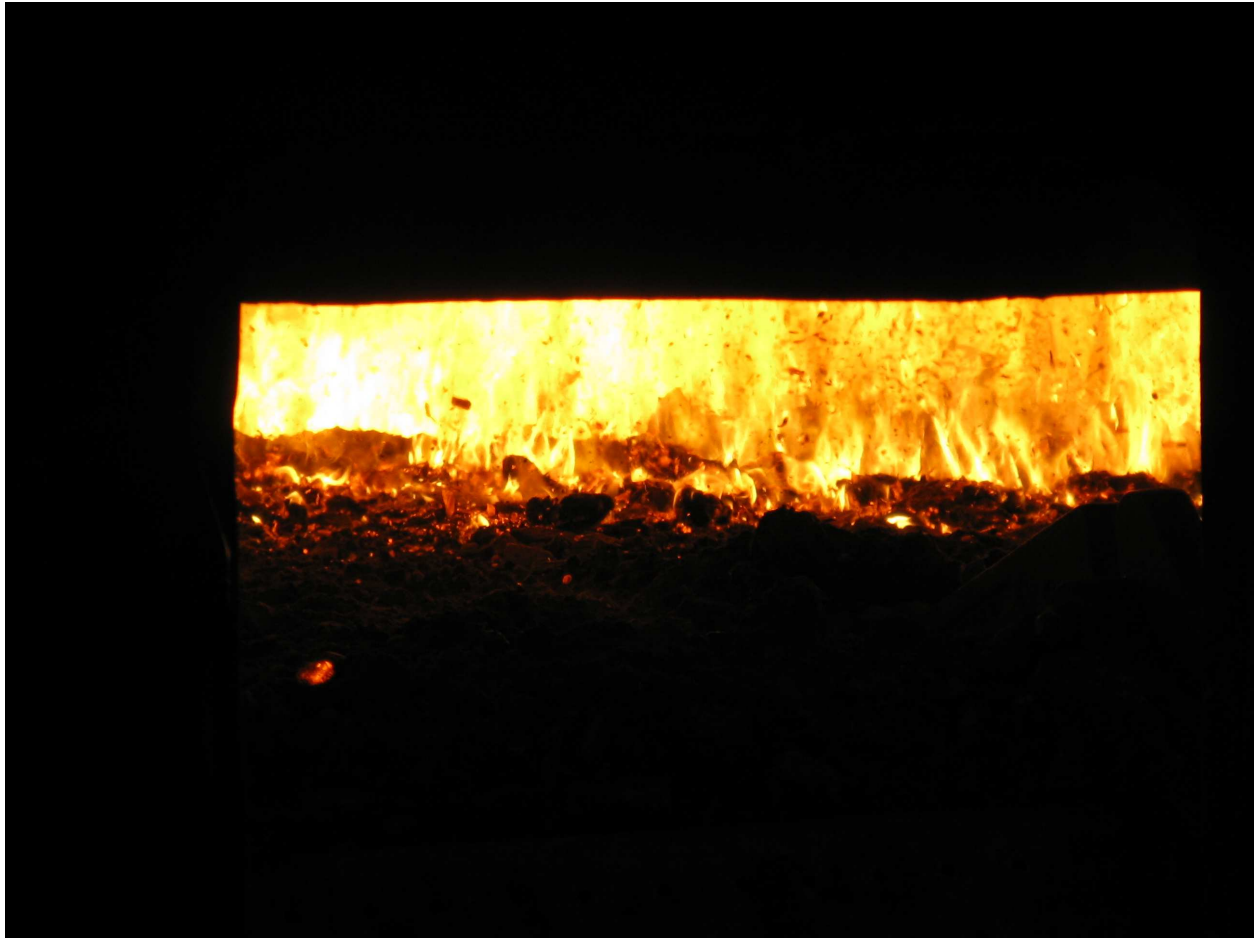
Another picture of the firebox showing the flame zone.

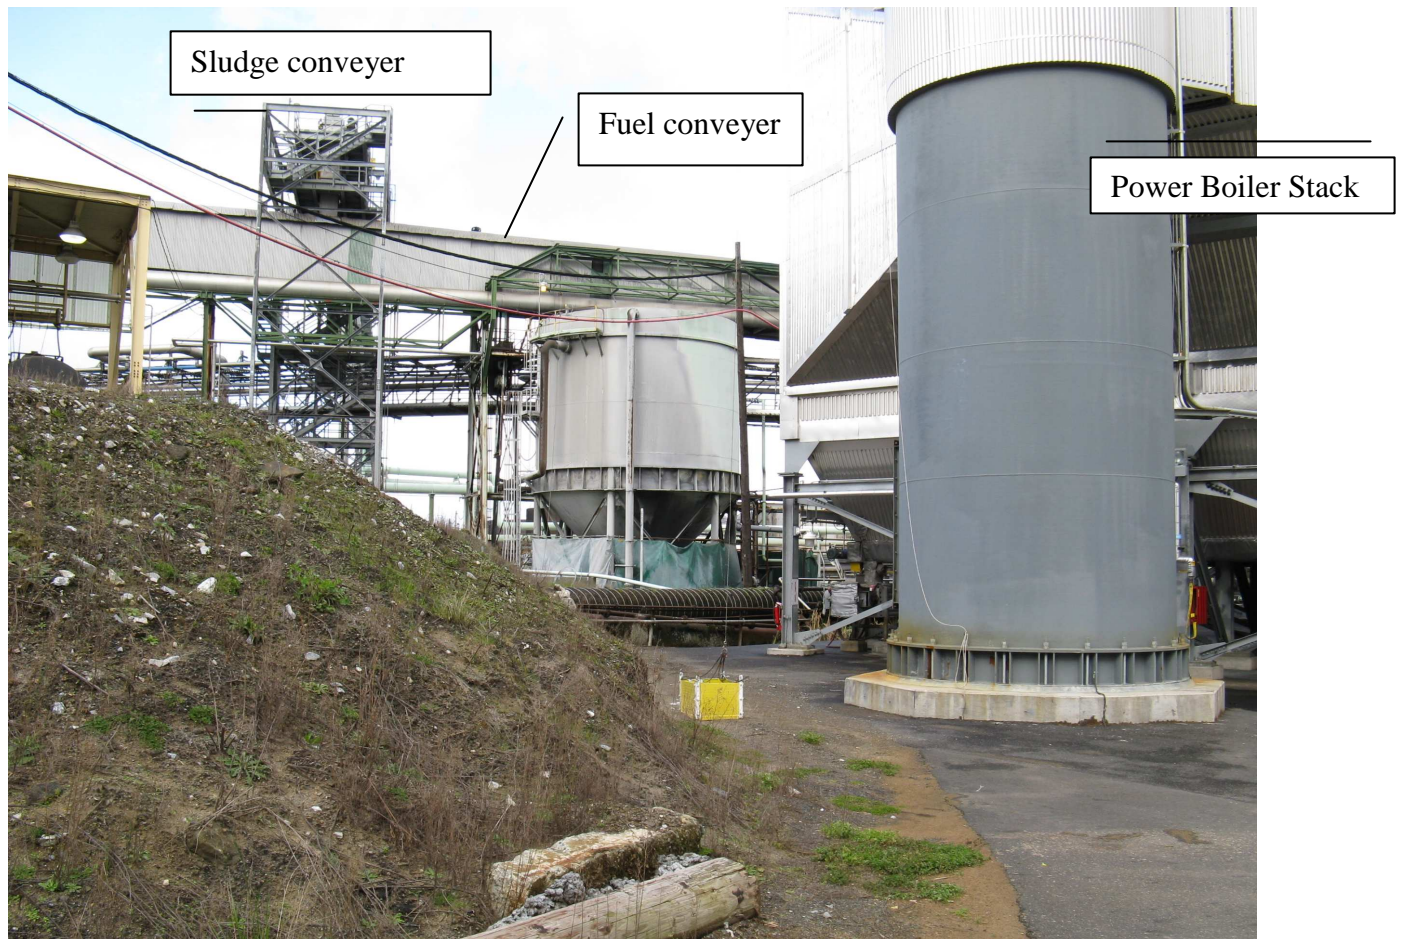
this shows the base of the #10 boiler stack at the right. In the center is an abandoned silo. The horizontal structure near the top of the picture is the fuel conveyer from the short-term fuel storage building (the cathedral, for its shape) the square framework above the fuel conveyor is where wastewater sludge is introduced to the fuel.

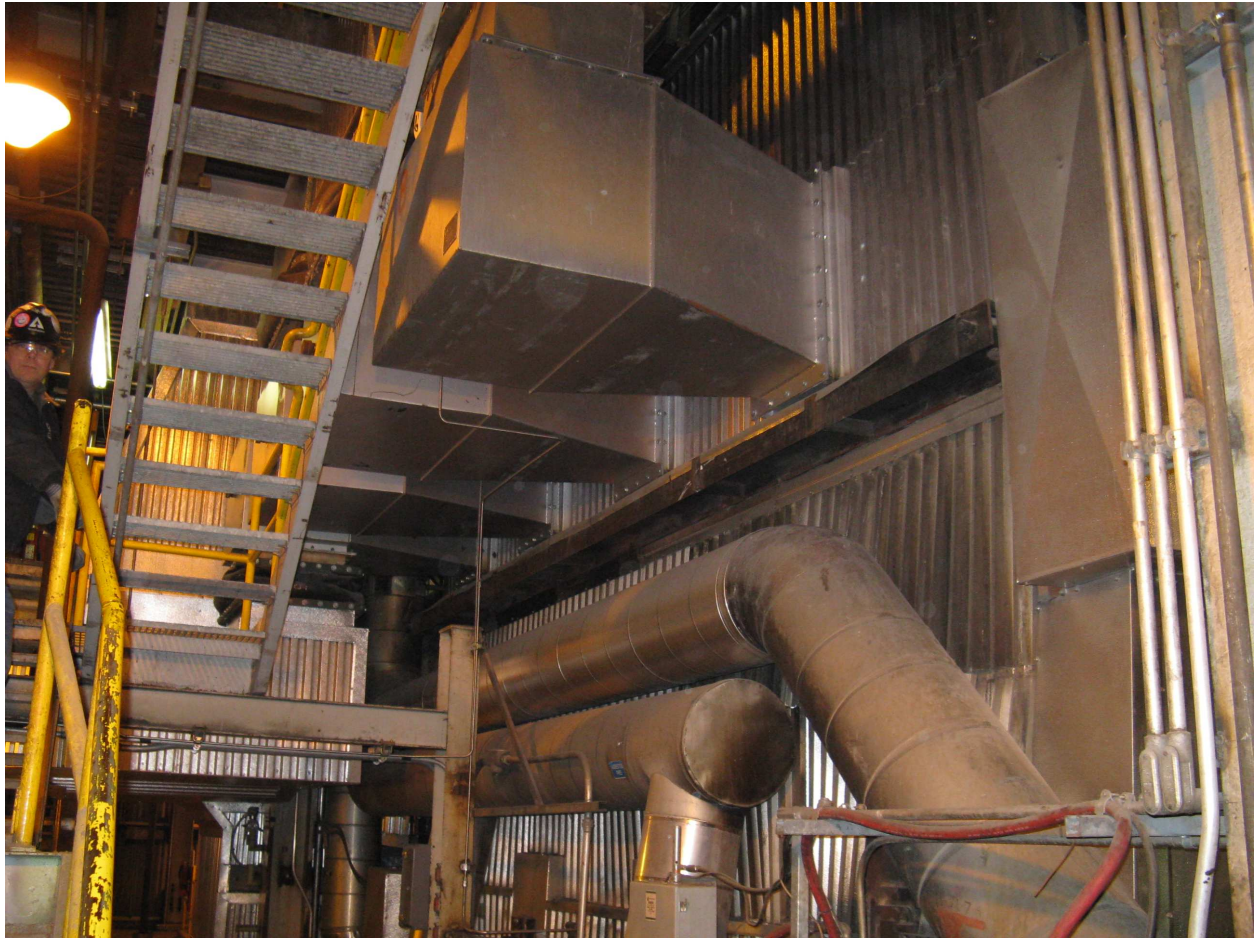
Power boiler secondary air inlets. These are new, inlets installed as part of air distribution optimization program.
